TECHNICAL REPORT GL-86-7

SEISMIC STABILITY EVALUATION OF ALBEN BARKLEY LOCK AND DAM PROJECT

Volume 5 STABILITY EVALUATION OF GEOTECHNICAL STRUCTURES

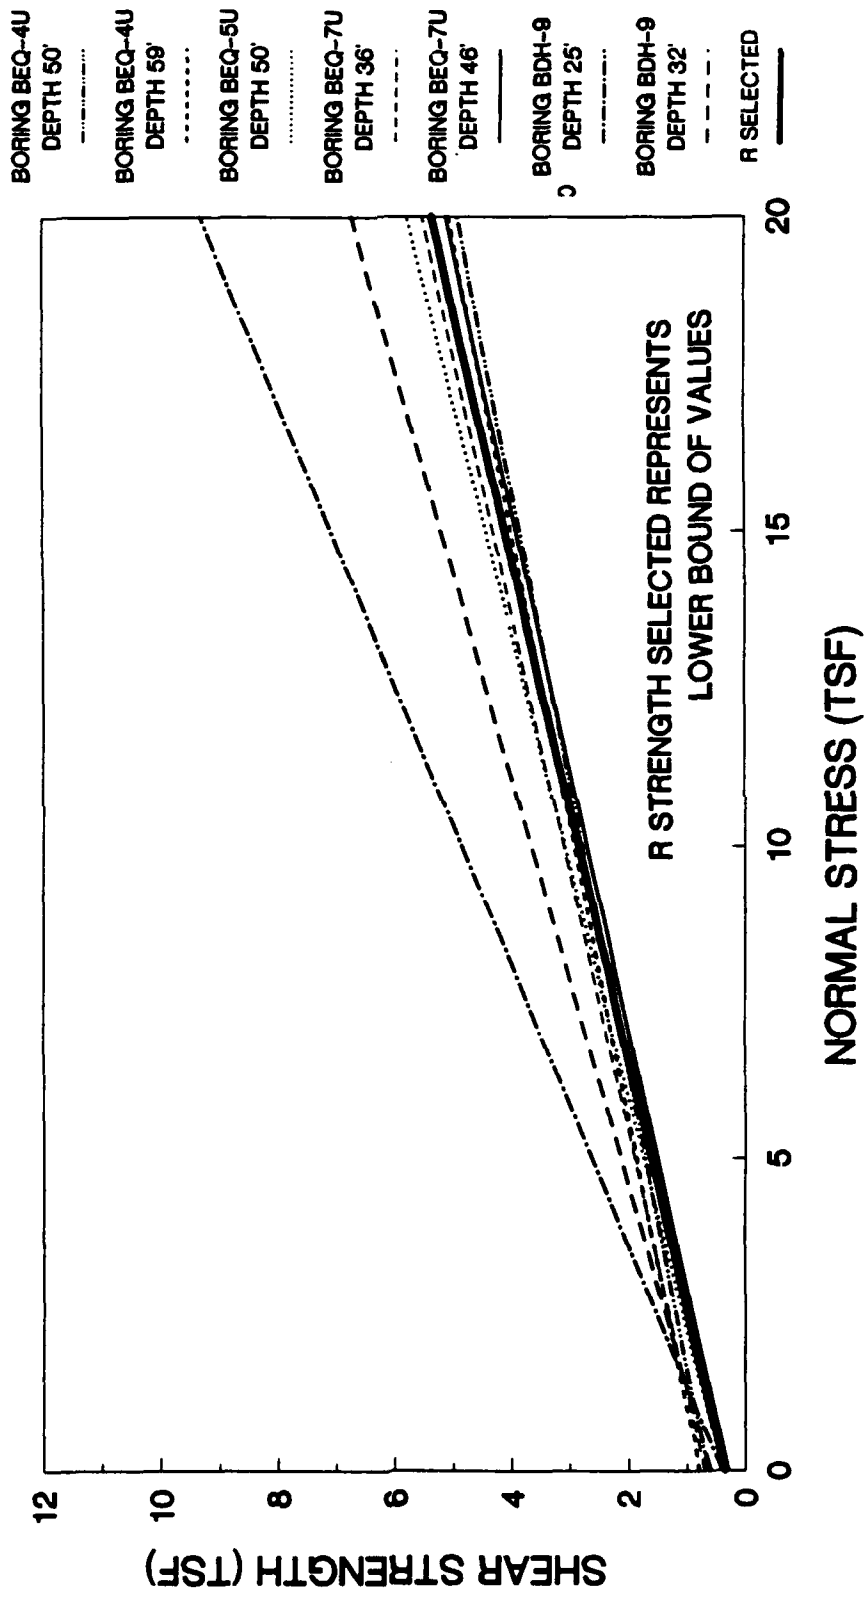
Figure 11. Consolidated - undrained (R) test envelopes for Unit 2 clay material.

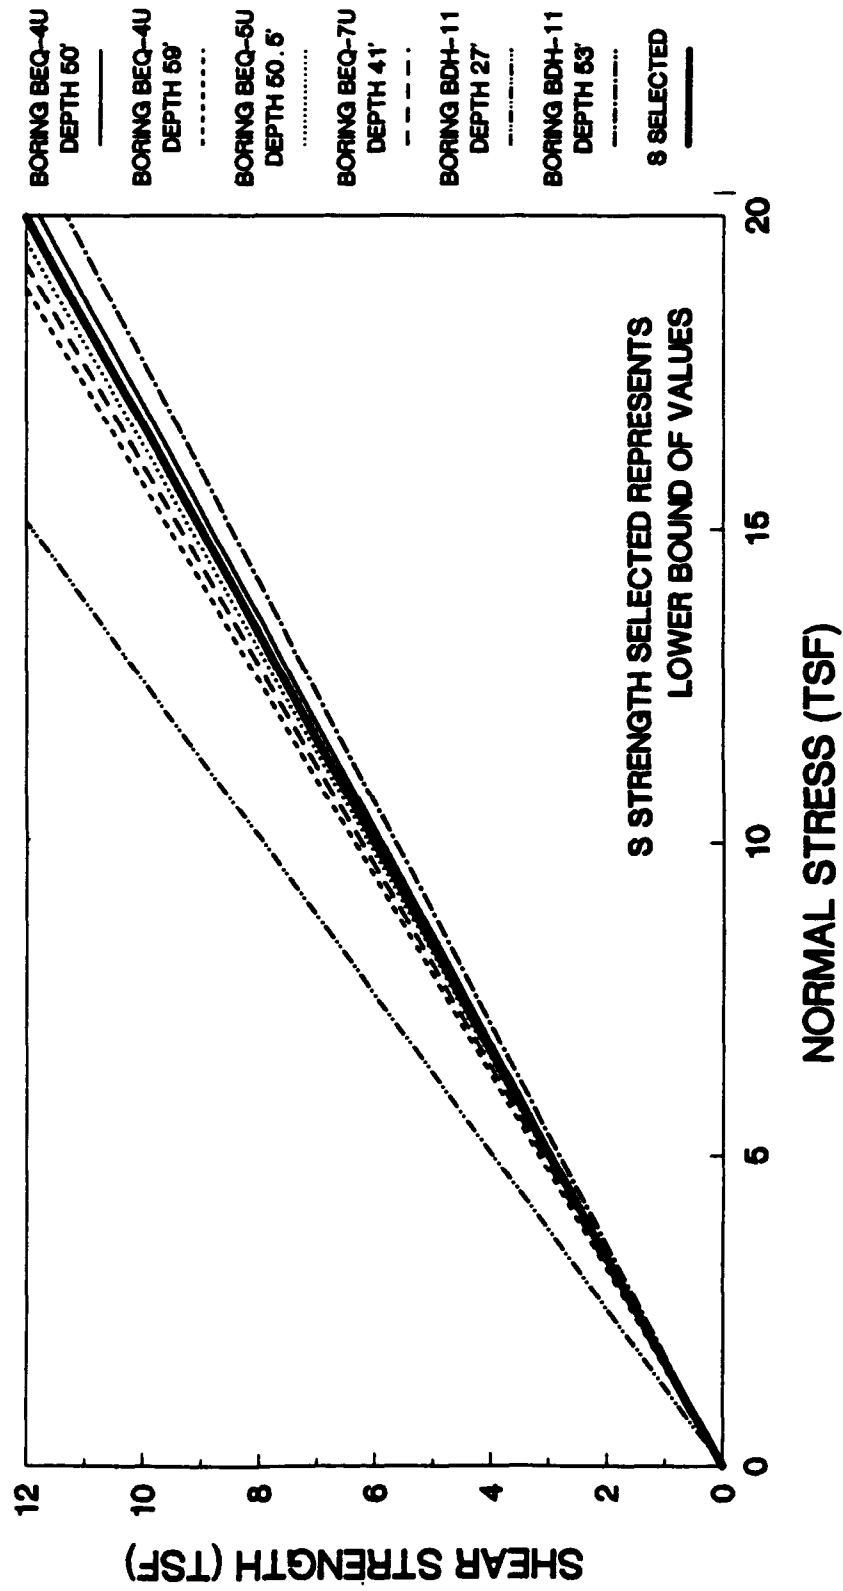
Figure 12. Consolidated - drained (S) test envelopes for Unit 2 clay material.

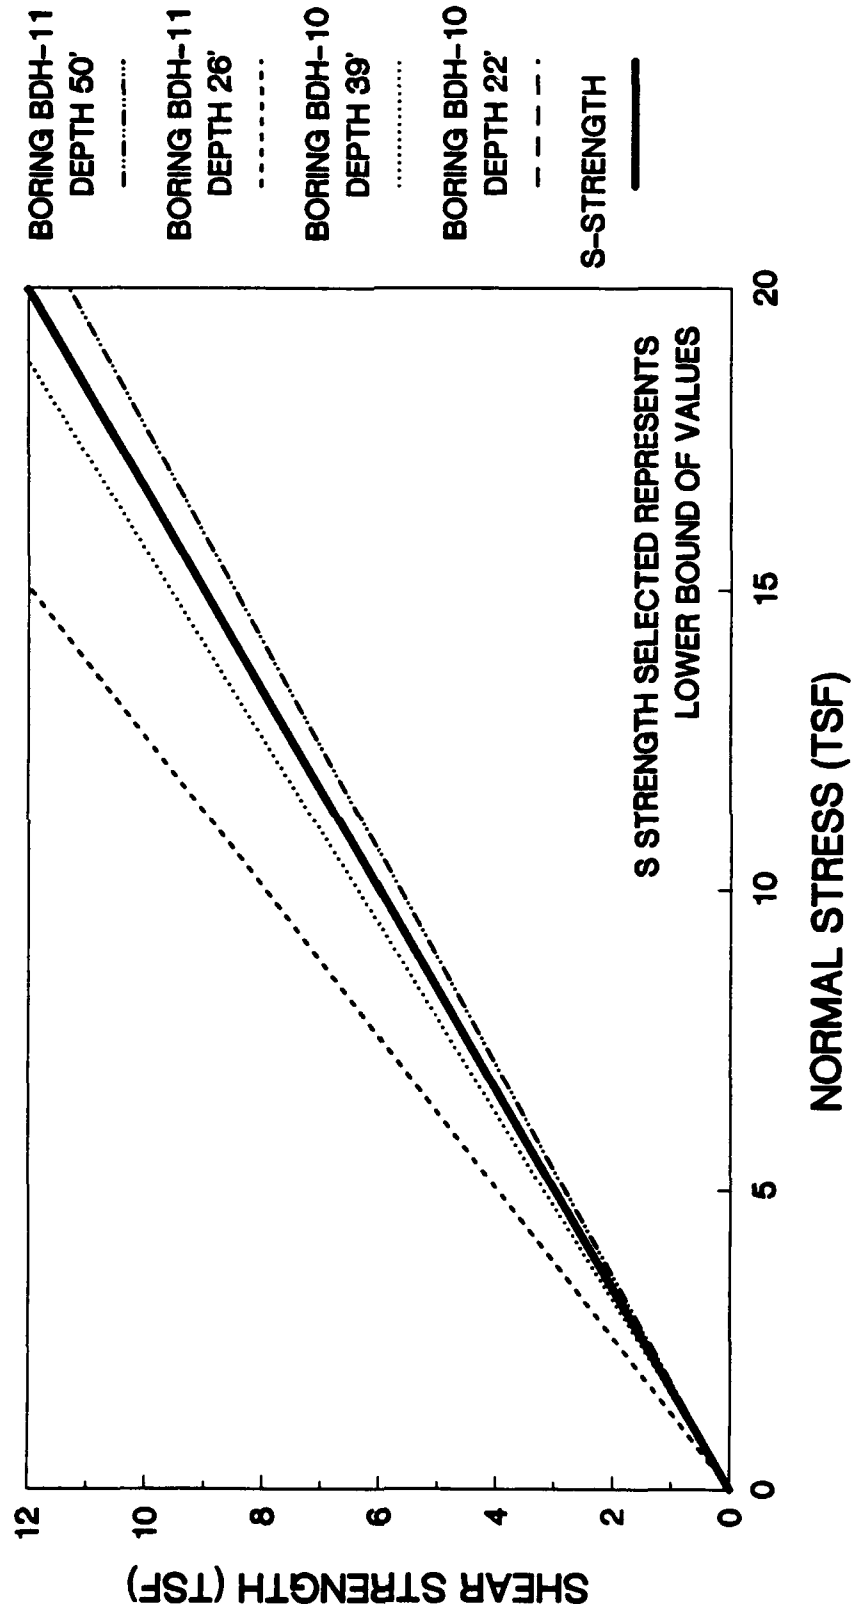
Figure 13. Consolidated - drained (S) test envelopes for Unit 2 sand material.

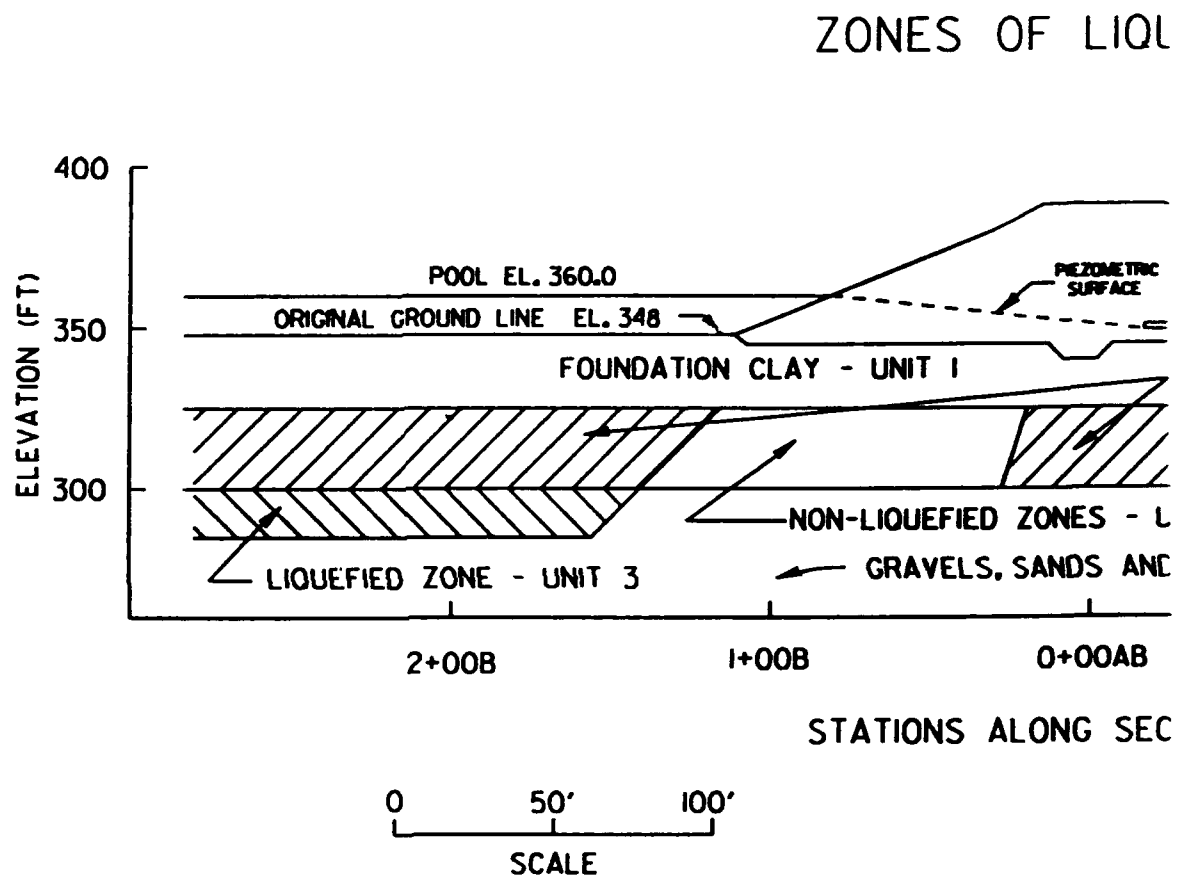
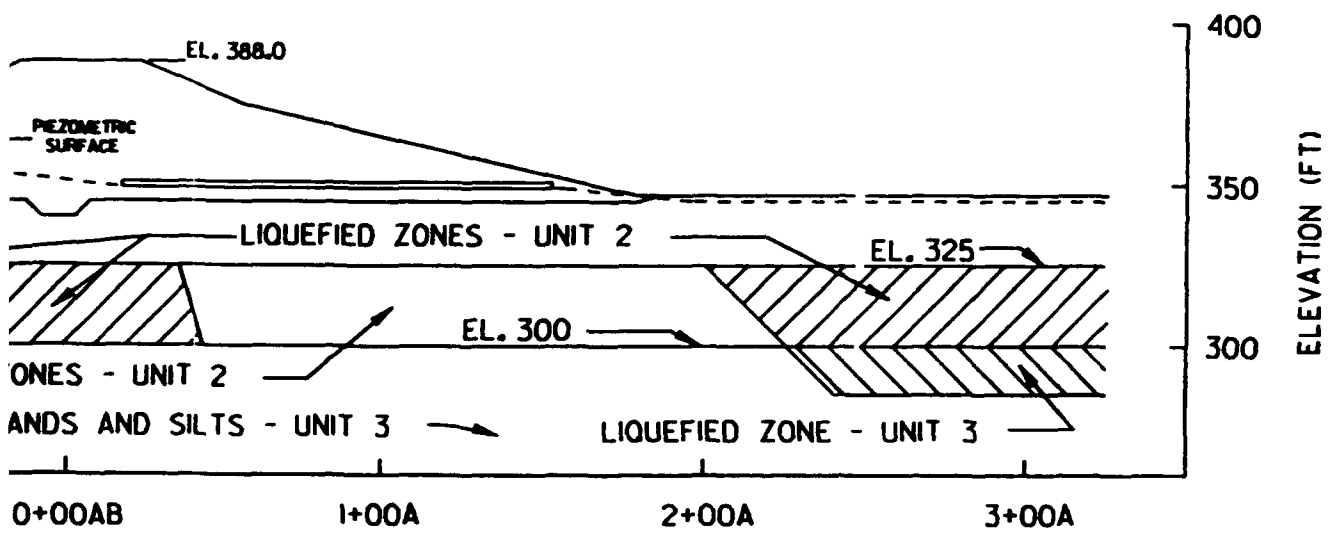
Figure 14. Main embankment

LIQUEFACTION

U.S. ARMY DISTRICT CORPS OF ENGINEERS MEMPHIS, TENNESSEE	
Drawn By:	BARKLEY DAM SEISMIC ANALYSIS MAIN EMBANKMENT ZONES OF LIQUEFACTION		
Checked By:			
DESIGNED			
Approved By:	Date:	Scale:	
Chief, MEMPHIS DISTRICT		Sheet of	
Chief, DISTRICT ENGINEER	Record Drawing as	Drawing Number

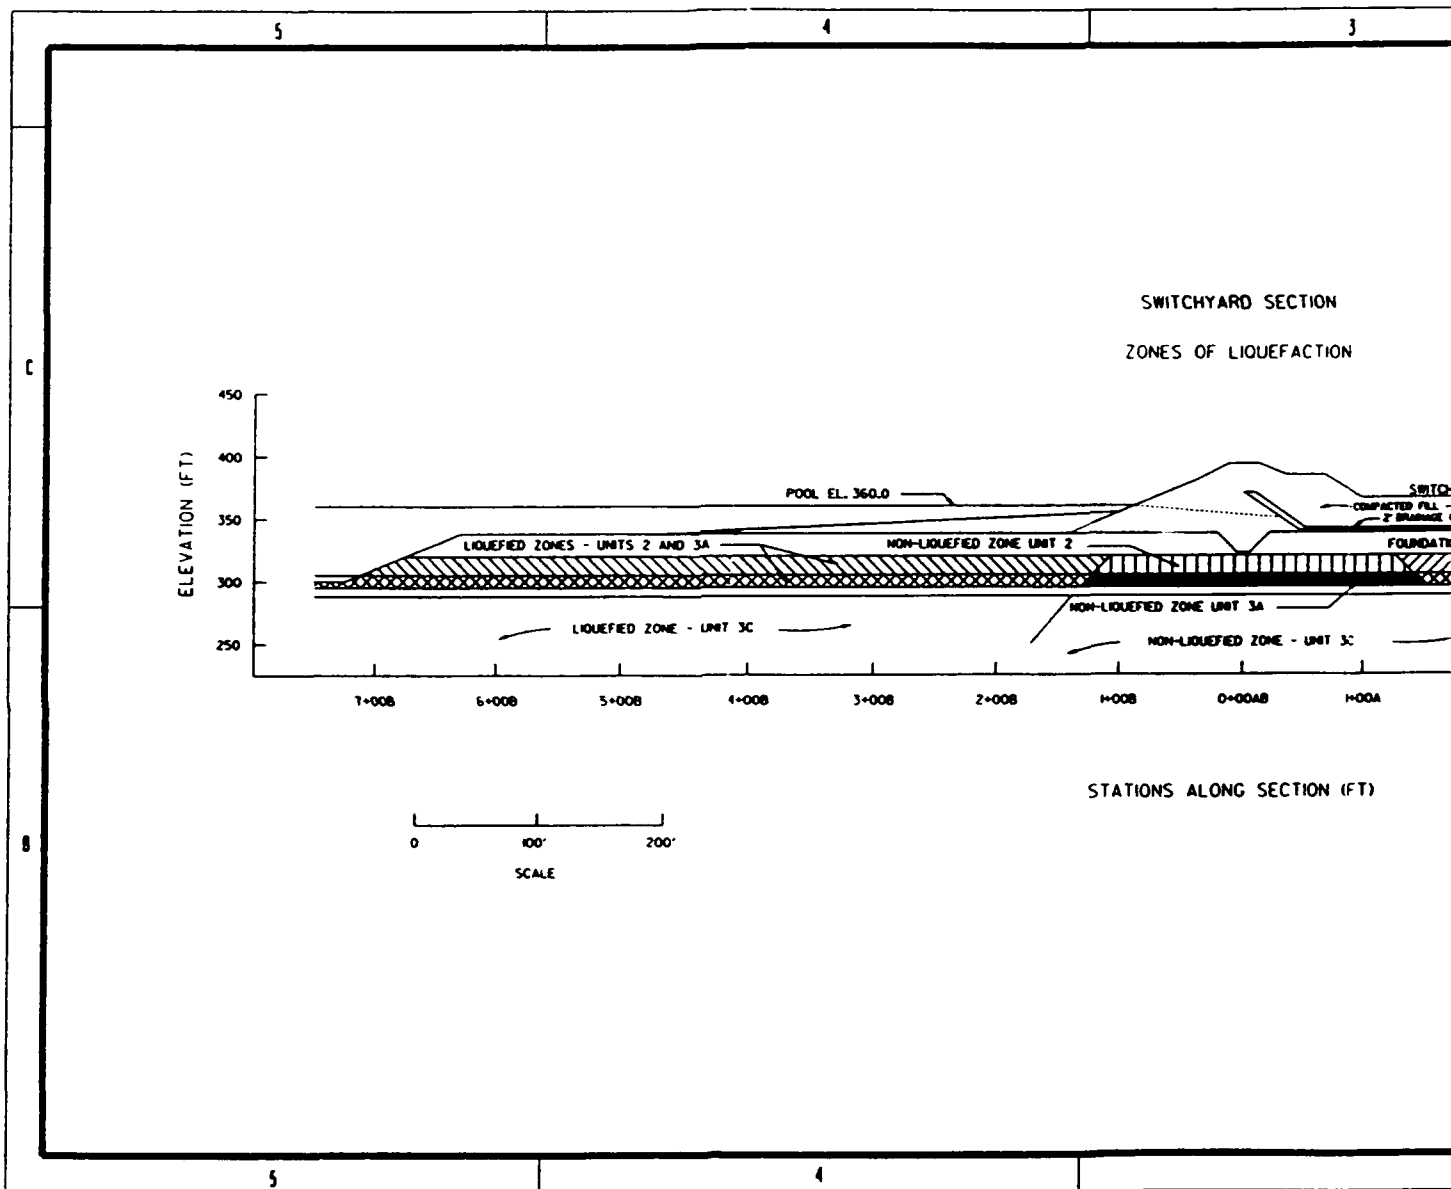
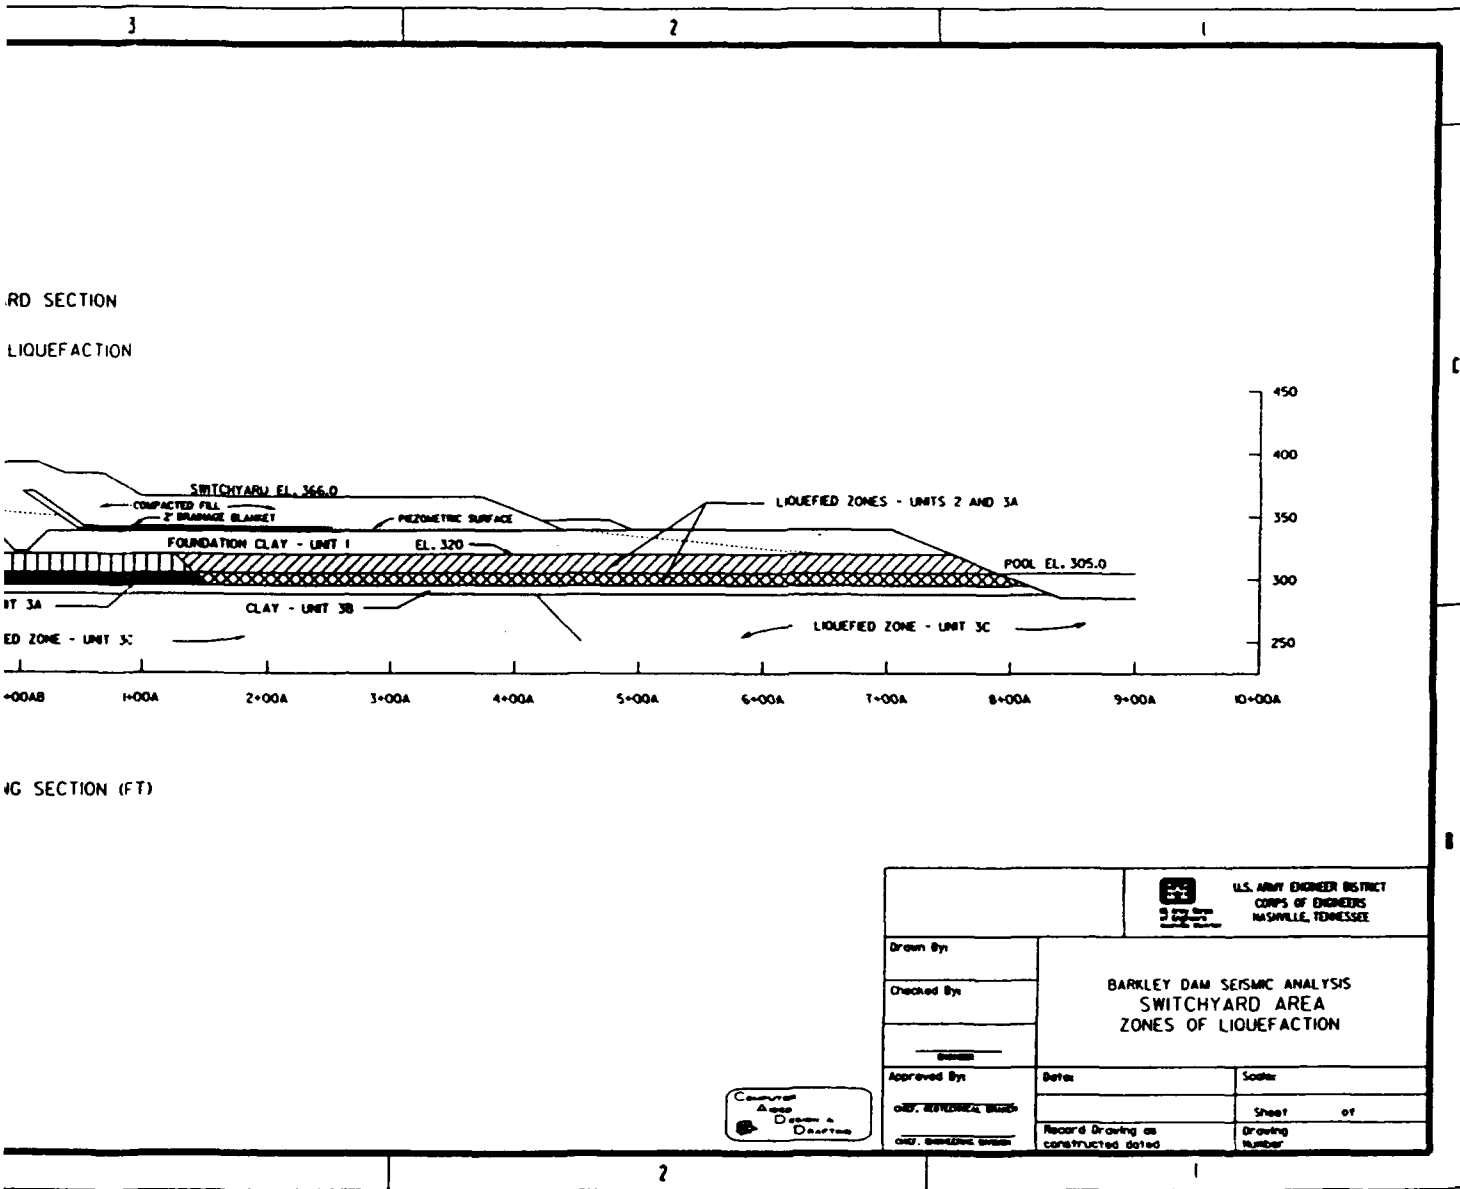
Figure 15. Zones of liquefaction f

liquefaction for the switchyard area.

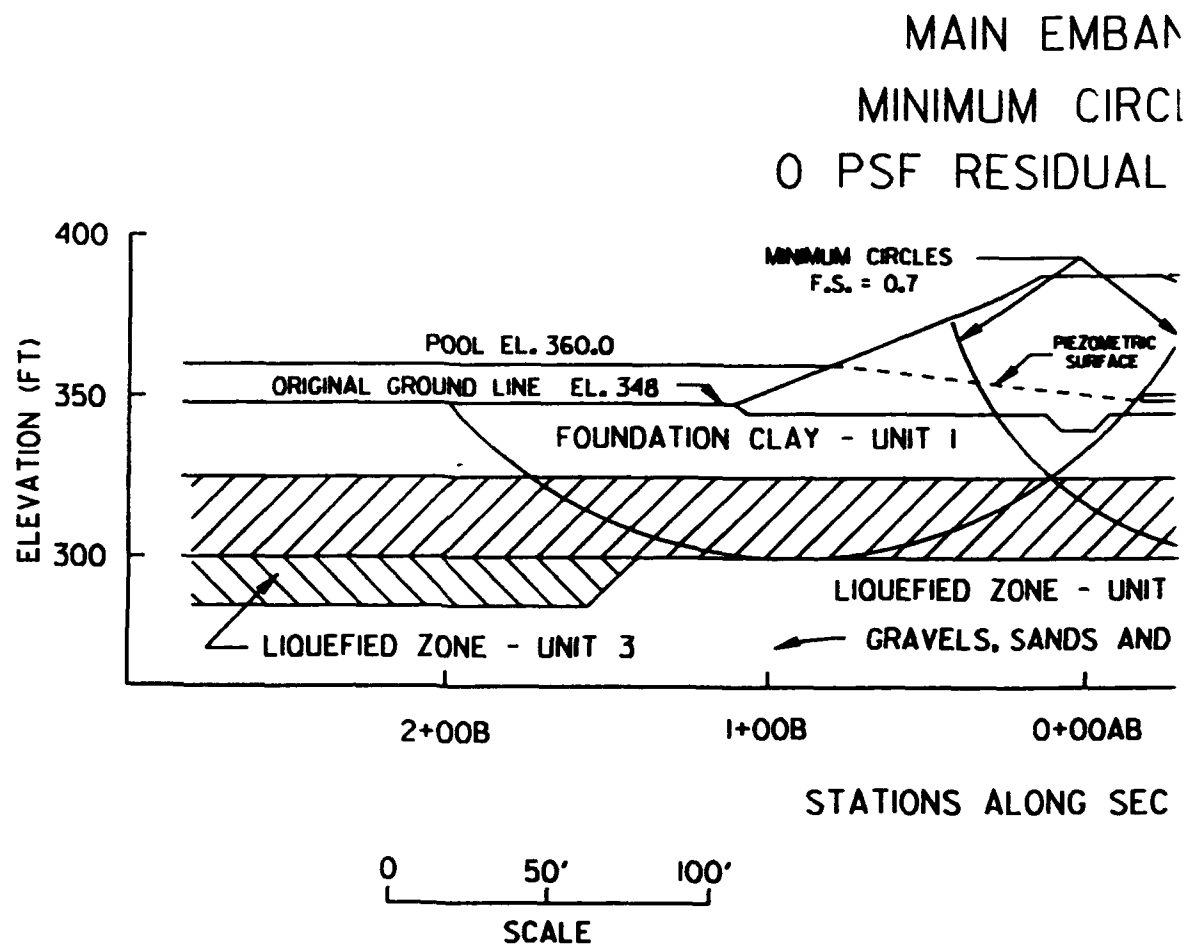
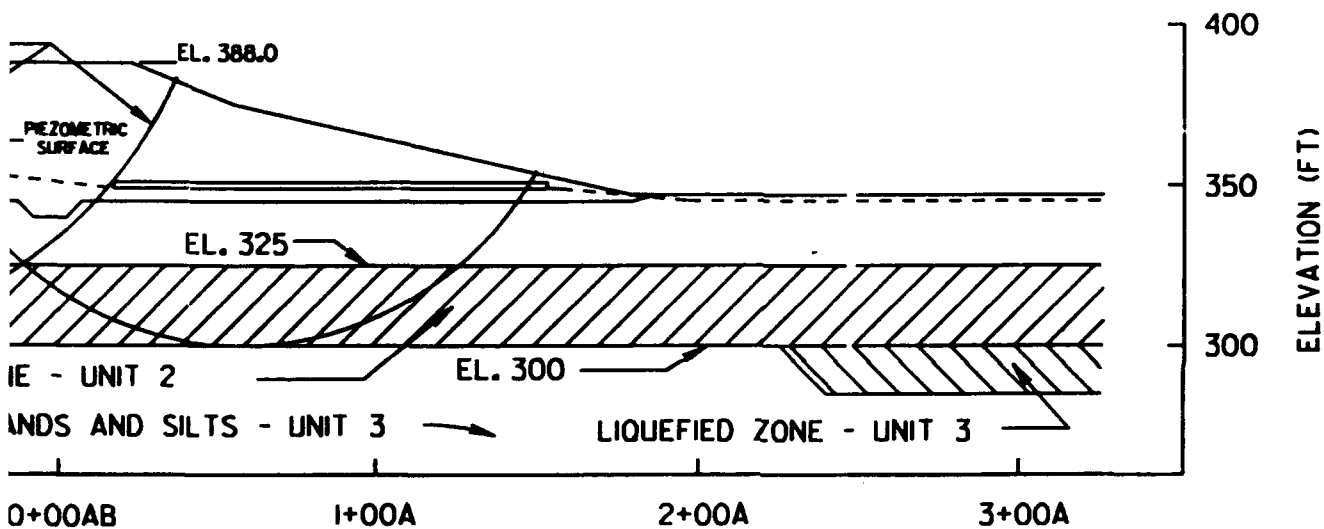
Figure 16. Minimum circles for 0 psf residual

MATERIAL	UNIT WEIGHT		C (PSF)	φ	% Ru
	γ_m	γ_{sat}			
COMPACTED FILL	126	128	800	18	---
UNIT 1 CLAY	115	125	960	12	---
LIQUEFIED ZONE - UNIT 2	122	126	0	0	---
UNIT 3 SANDS	126	128	0	35	50
LIQUEFIED ZONE - UNIT 3	126	128	0	0	---

41. Main Embankment: When a zero strength was assumed in the critical zone as defined by the liquefaction analysis, the resulting minimum factors of safety for the upstream and downstream slopes were both 0.7 with the minimum circles tangent to a plane at elevation 300 feet (see Figure 16). Using the full residual strength of 700 psf for the liquefied soil produced factors of safety of 1.3 for both the upstream and downstream slopes (see Figure 17). (By comparison, the pre-earthquake safety factors for both the upstream and downstream failure surfaces were 3.2). Thus, according to Paragraph 37, sliding and large scale deformations are not expected to occur however, both the upstream and downstream portion of the main dam are expected to undergo large strains. Seed has estimated that the strains required to mobilize the full residual strength are about 25% (See Seed's letter dated February 3, 1986 in Appendix A of Report 1).

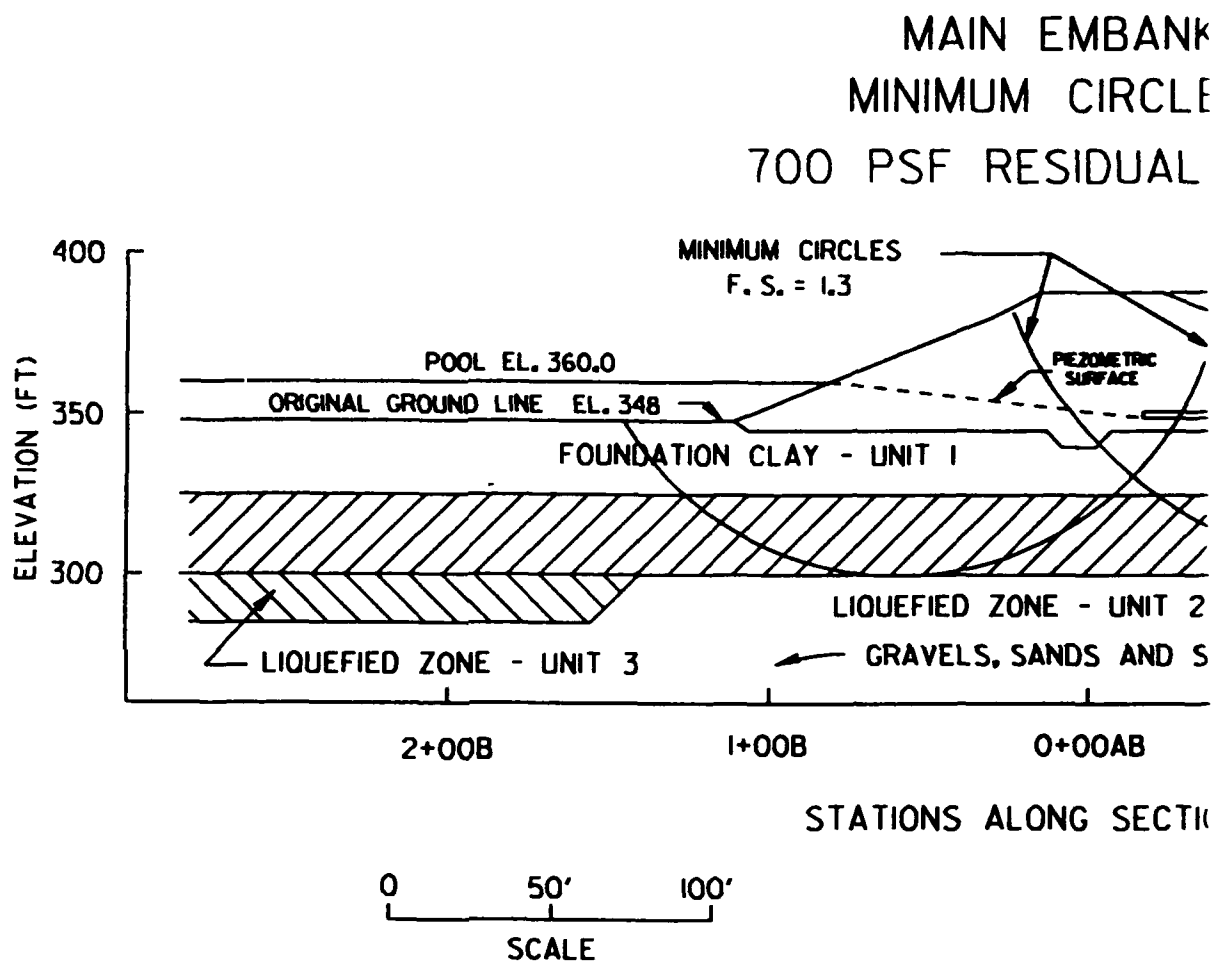
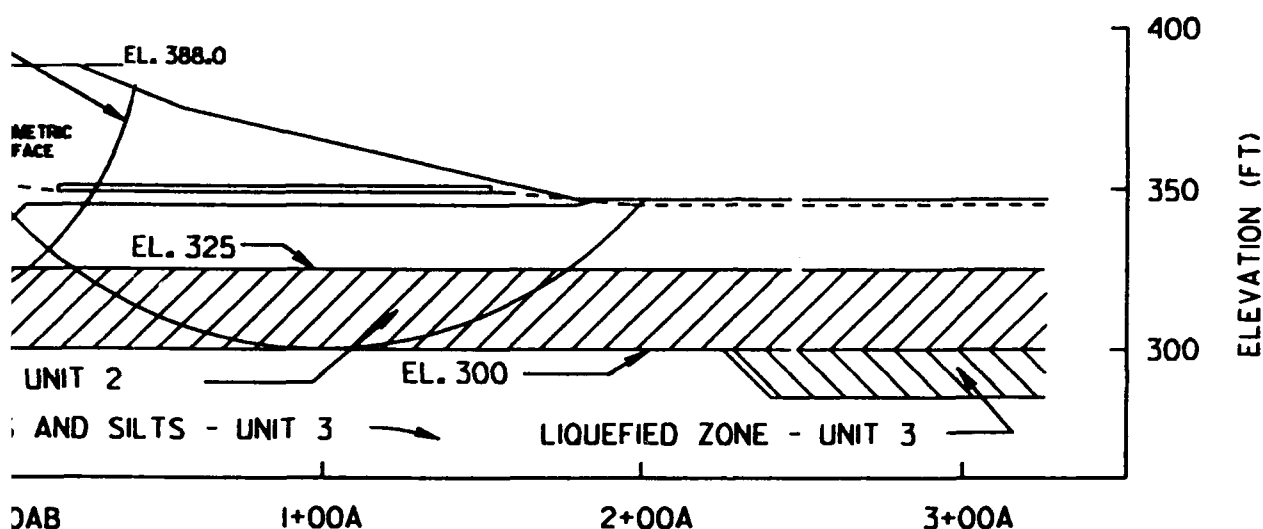
Figure 17. Minimum circles for 700 psf res.

MATERIAL	UNIT WEIGHT		C (PSF)	ϕ	% Ru
	γ_m	γ_{sat}			
COMPACTED FILL	126	128	800	18	---
UNIT 1 CLAY	115	125	960	12	---
LIQUEFIED ZONE - UNIT 2	122	126	700	0	---
UNIT 3 SANDS	126	128	0	35	50
LIQUEFIED ZONE - UNIT 3	126	128	800	0	---

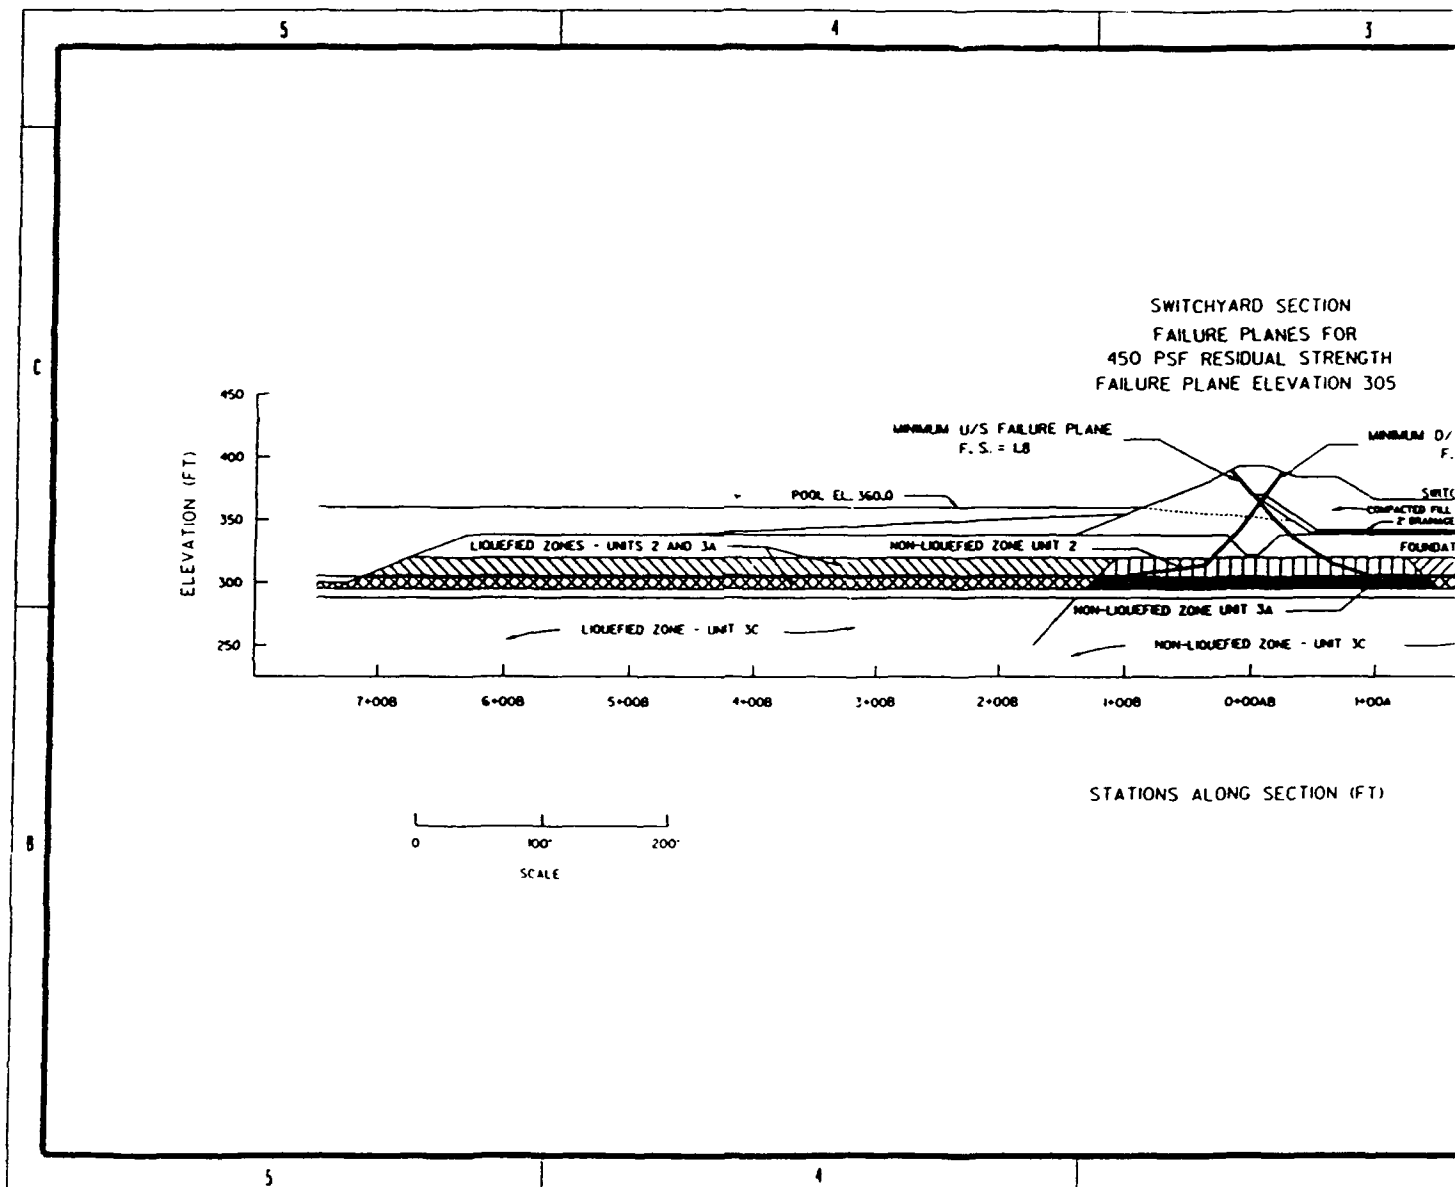
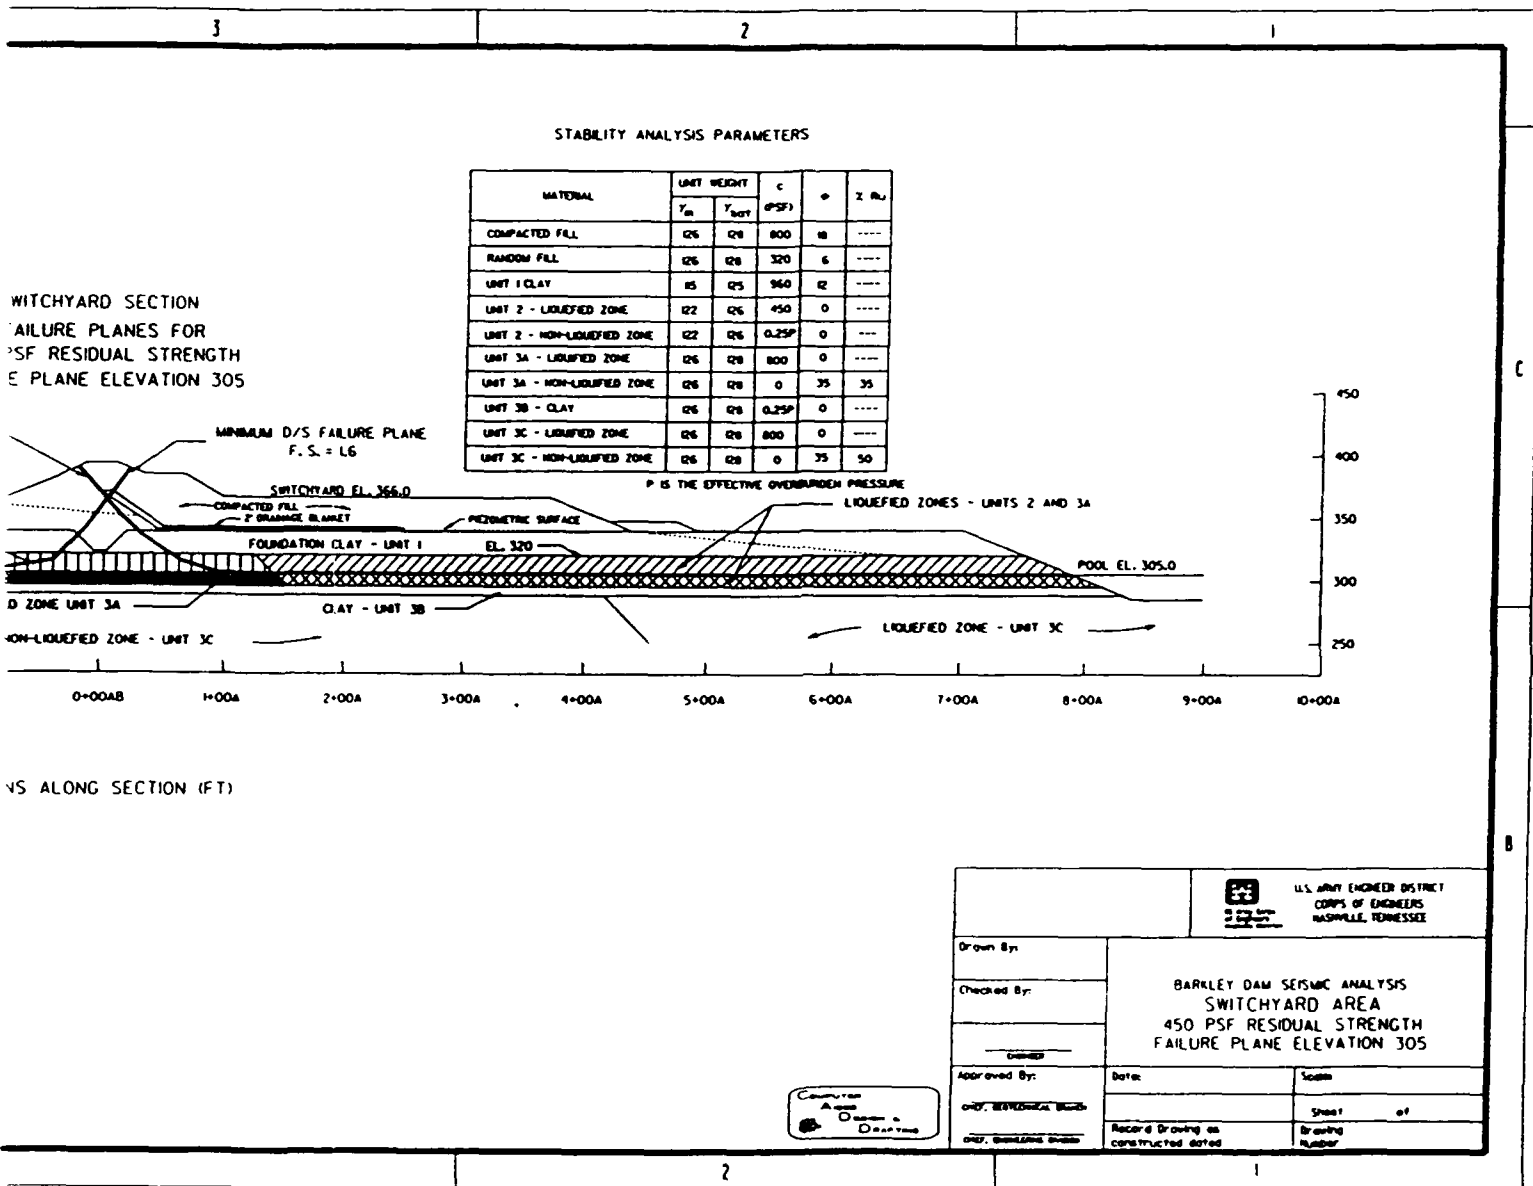
Figure 18. Minimum failure planes a
450 psf residual strength in liq

failure planes at elevation 305 feet with
strength in liquefied zone of Unit 2.

42. Switchyard Section: Because liquefaction can occur in Units 2, 3A and 3C, stability analyses were performed on failure planes at elevations of 305, 295 and 288 feet (the search routine on the computer program found that the critical failure planes for this units corresponded to the base elevations of the these Units). As outlined in Paragraph 37, the full residual strength was used for the liquefied zones and the minimum factors of safety were determined for the failure planes at the three elevation intervals. The minimum failure planes are shown in Figures 18-23.

43. Using the full residual strength of 450 psf, the minimum failure plane occurs at elevation 305 feet with factors of safety of 1.6 and 1.8 for the downstream and upstream slopes, respectively. Therefore, large scale movements and deformations are not anticipated in this area. However, using zero strength in the critical zone for failure plane elevations of 305 feet will result in factors of safety less than one for both the upstream and downstream conditions (0.8 and 0.7, respectively). Analyses were then performed assuming that the dam has strained and the residual strength required to produce a stable condition (factor of safety = 1.2) was determined. For the minimum failure planes at this elevation, a residual strength of about 200 psf is needed to produce a stable condition for the upstream slope and 250 psf for the downstream slope, which is less than the estimated maximum residual strength of 450 psf of the soil. The pre-earthquake safety factors for the upstream and downstream surfaces are 4.4 and 5.6, respectively. Figures 18-19 shows the location of the failure surfaces and Table 2 summarizes the results.

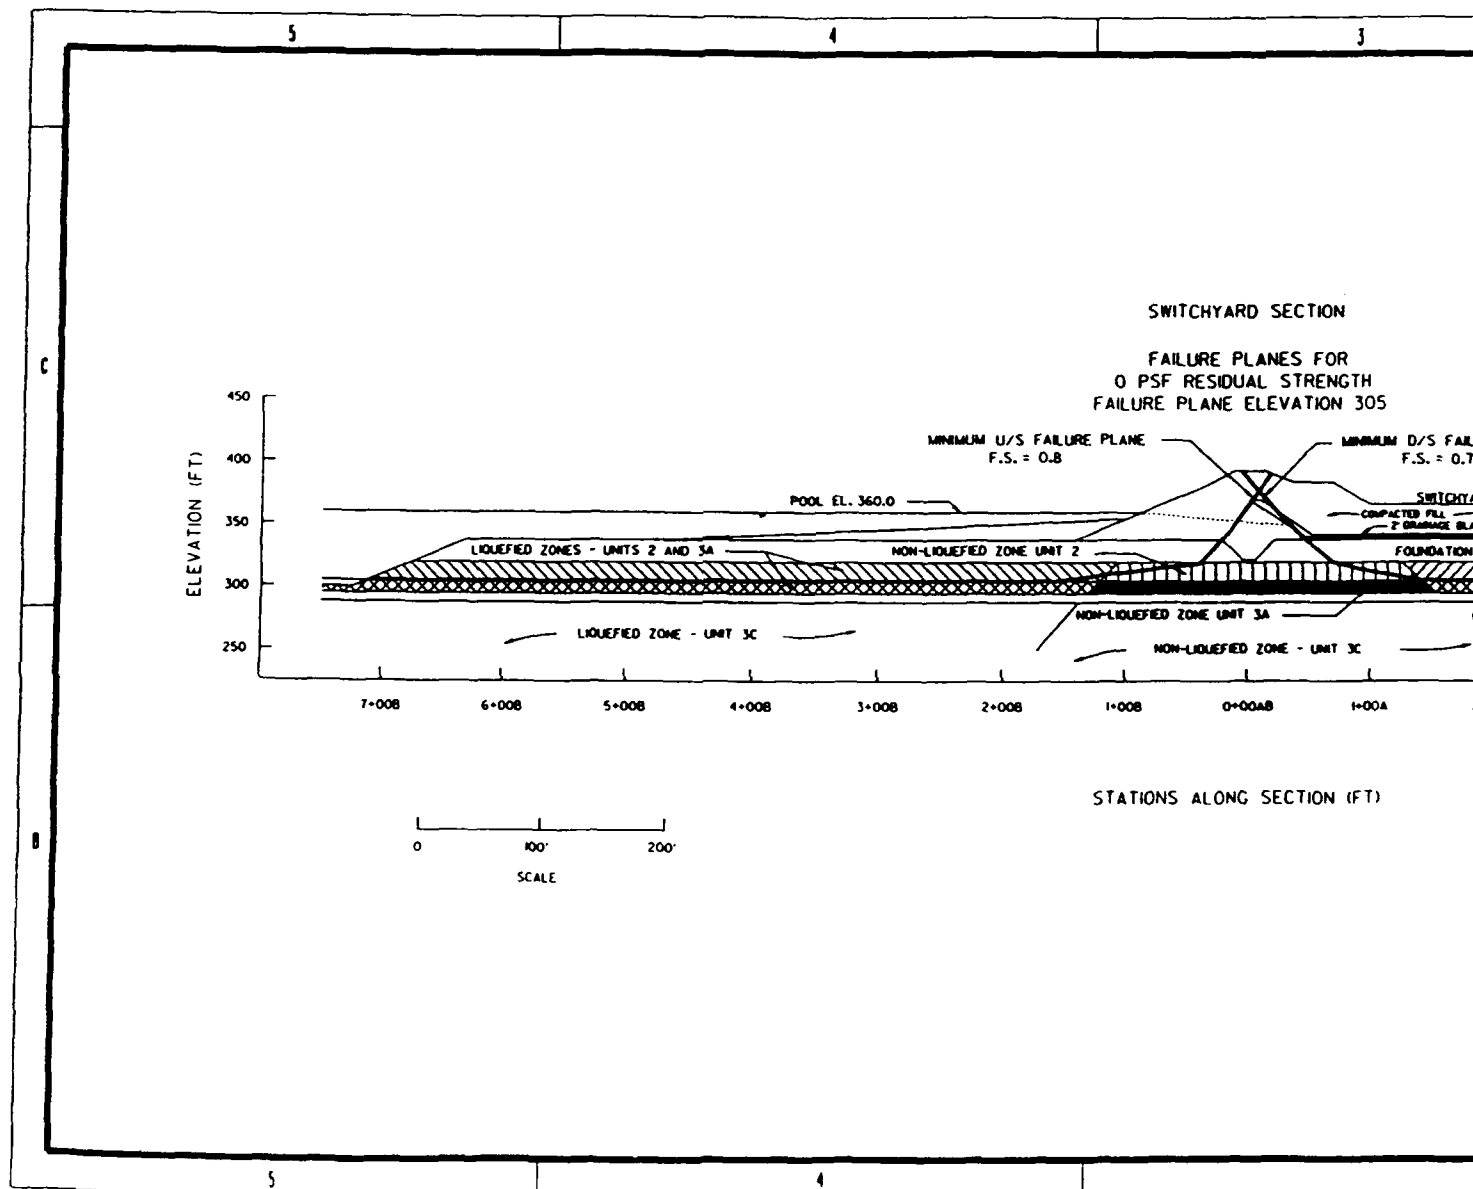
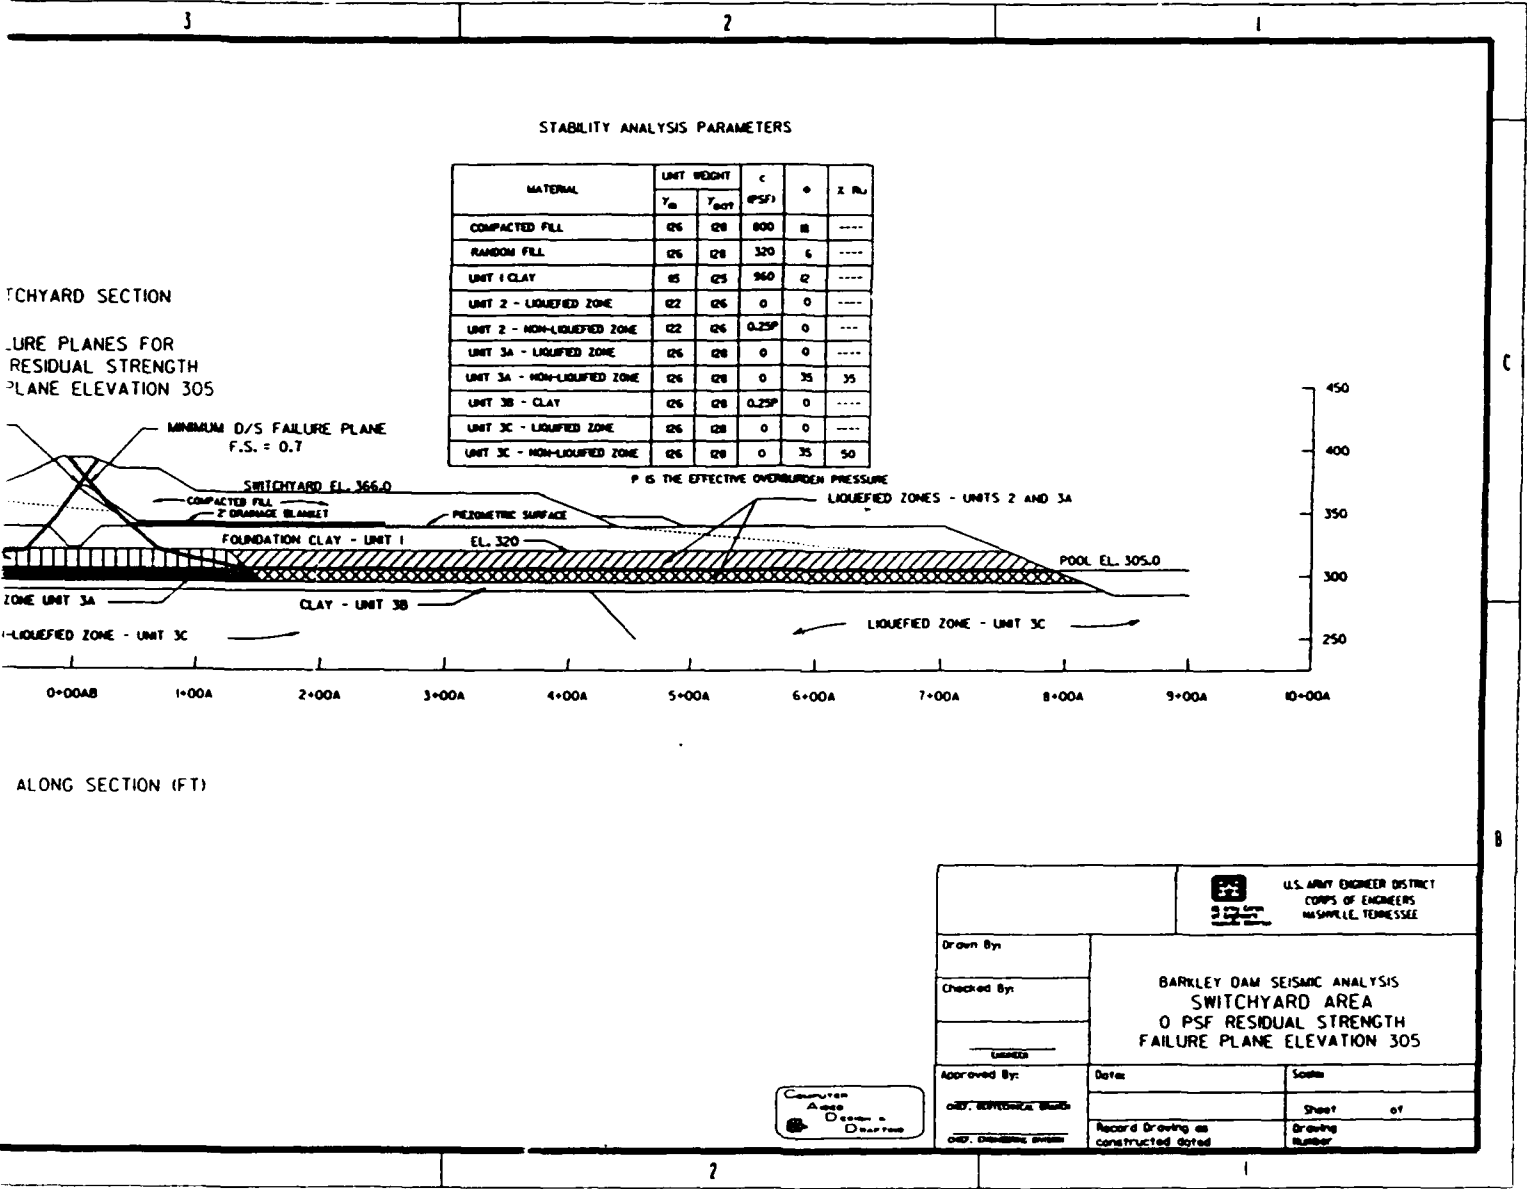
Figure 19. Minimum failure planes at e
0 psf residual strength in liquefi

Failure planes at elevation 305 feet with residual strength in liquefied zone of Unit 2.
